4.1 GENERAL DESIGN CONSIDERATIONS

This chapter discusses structural, building envelope, and nonstructural building systems, and illustrates various types of wind-induced damage that affect them. It also presents six case studies. Numerous examples of best practices pertaining to new and existing hospitals are presented as recommended design guidelines. Incorporating those practices applicable to specific projects will result in greater wind-resistance reliability and will, therefore, decrease expenditures for repair of wind-damaged facilities, provide enhanced protection for occupants, and avoid disruption of critical services.

The recommendations presented in this manual are based on field observation research conducted on 25 hospitals that were struck by

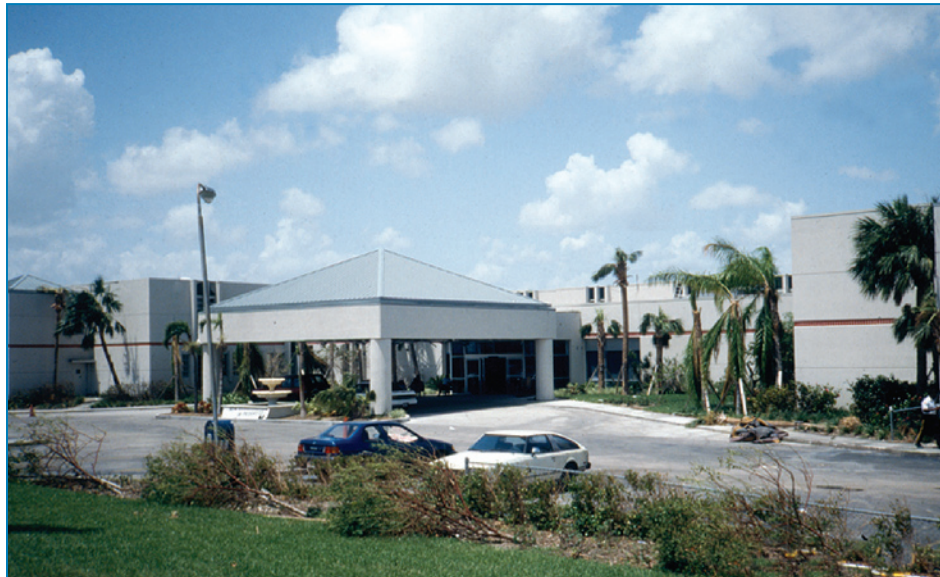
Figure 4-1:
Deering Hospital
was evacuated after
Hurricane Andrew due
to water infiltration
caused by roof
covering, window,
and door damage.

The 200-bed Deering Hospital opened shortly before Hurricane Andrew struck south Florida in 1992. Aggregate from the hospital's built-up roofs broke several windows, the roof covering was blown off in some areas (Figure 4-9), and the entrance doors at the emergency room were blown away. Because of extensive interior water damage, the entire hospital was evacuated after the storm and remained closed for 9 months.

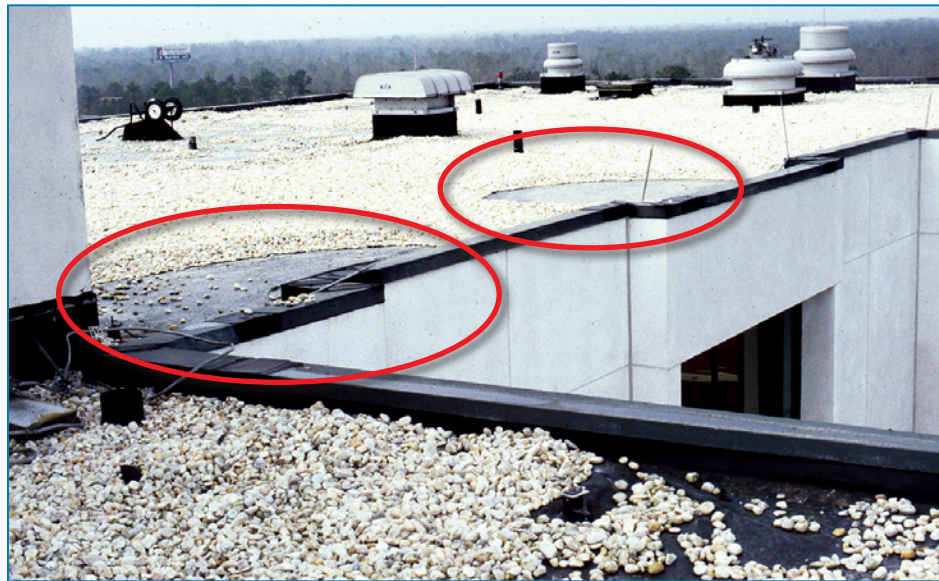
Figure 4-5:
Aggregate blow-off associated with building irregularities. Hurricane Hugo (South Carolina, 1989)

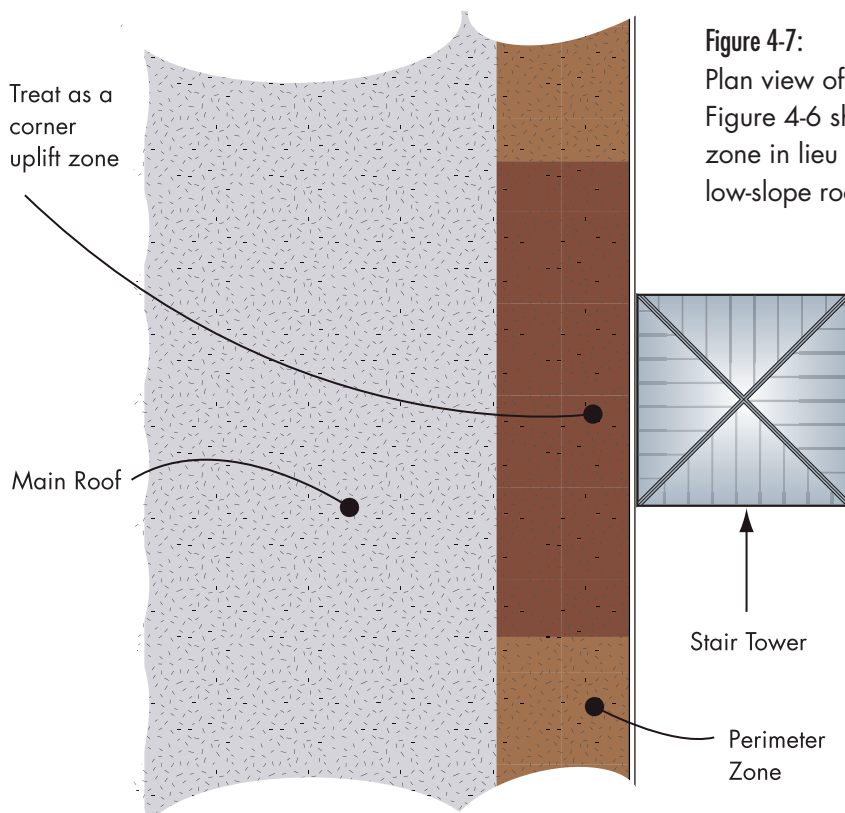
Figure 4-6 shows a stair tower at a hospital that caused turbulence resulting in wind speed-up. The speed-up increased the suction pressure on the base flashing along the parapet behind the stair tower. The built-up roof's base flashing was pulled out from underneath the coping because its attachment was insufficient to resist the suction pressure. The base flashing failure propagated and caused a large area of the roof membrane to lift and peel. Some of the wall covering on the stair tower was also blown away. Had the stair tower not existed, the built-up roof would likely not have been damaged. To avoid damage in the vicinity of building irregularities, attention needs to be given to the attachment of building elements located in turbulent flow areas.

Figure 4-6:
The irregularity created by the stair tower (covered with a metal roof) caused turbulence resulting in wind speed-up and roof damage. Hurricane Andrew (Florida, 1992)

To avoid the roof membrane damage shown in Figure 4-6, it would be prudent to use corner uplift loads in lieu of perimeter uplift loads in the vicinity of the stair tower, as illustrated in Figure 4-7. Wind load increases due to building irregularities can be identified by wind tunnel studies; however, wind tunnel studies are rarely performed for hospitals. Therefore, identification of wind load increases due to building

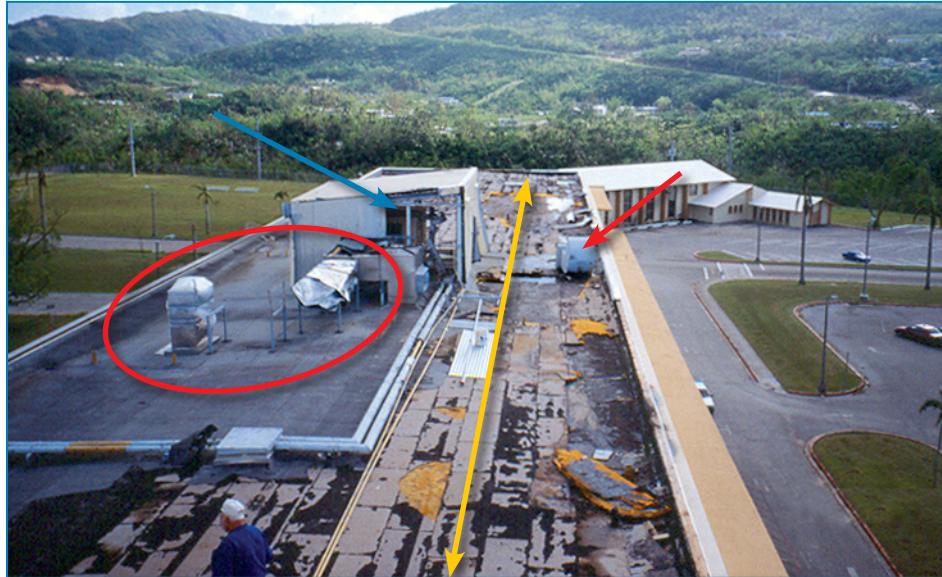
Roof: Roof covering damage (including rooftop mechanical, electrical, and communications equipment) is the most common type of wind damage, as illustrated by Figure 4-9. In addition to blowoff of the roof membrane (yellow arrow), ductwork blew away (red circle), a gooseneck was blown over (red arrow), and wall panels at an equipment enclosure were blown off (blue arrow). The cast-in-place concrete deck kept most of the water from entering the hospital.

Figure 4-9:
Damaged roof
membrane and rooftop
equipment. Typhoon
Paka (1997)

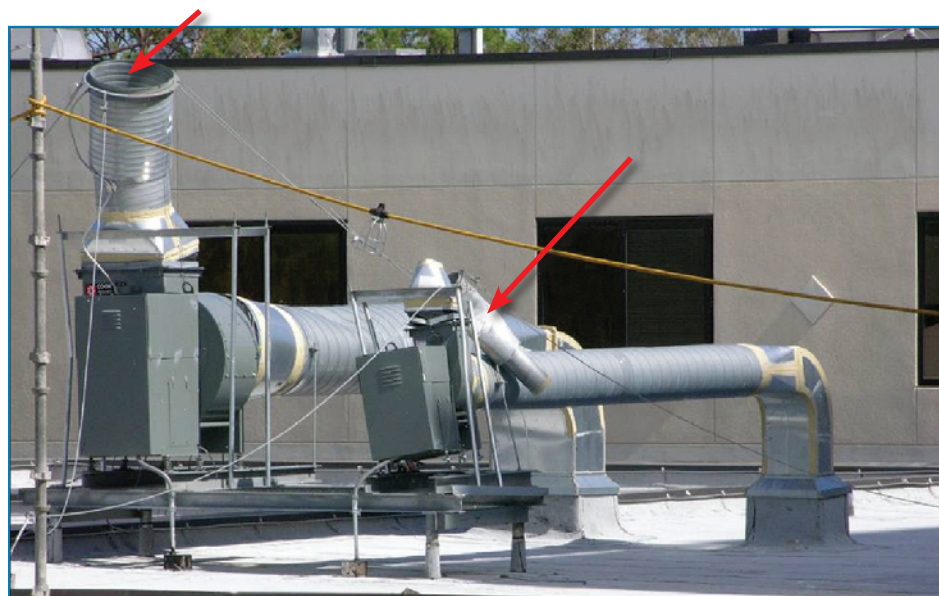
Figure 4-16:
 Damaged rooftop equipment. Although some of this damage may have been caused by wind pressure, some of it was caused by missiles. Note the open ducts (red arrows).

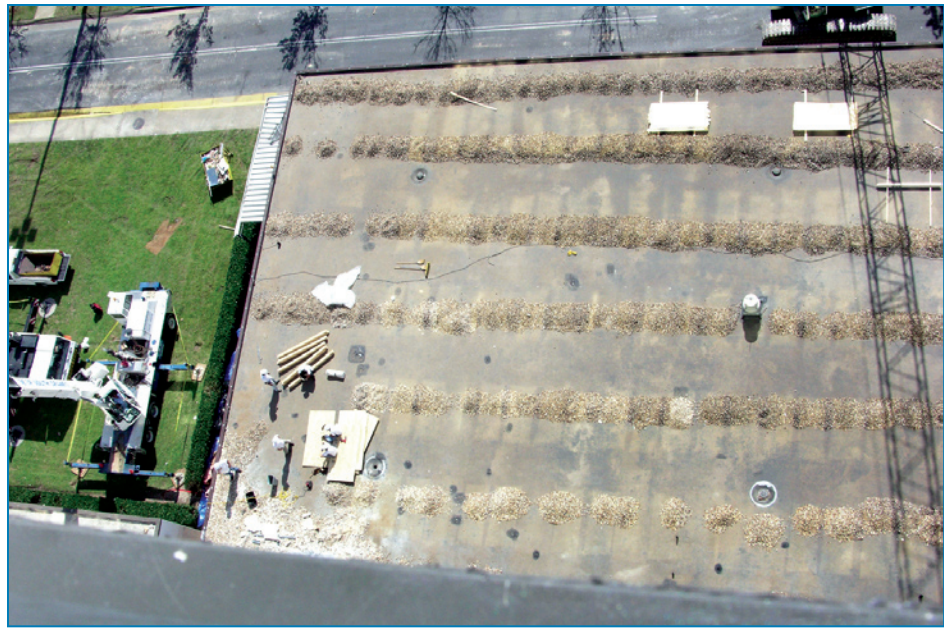
Looking down at the one-story roof to the right of the MOB in Figure 4-19. The small dark areas are locations where emergency patches had been placed to repair punctures from falling glass shards. (Note: At the time the photo was taken, the ballast had been repositioned into rows in preparation for removal)

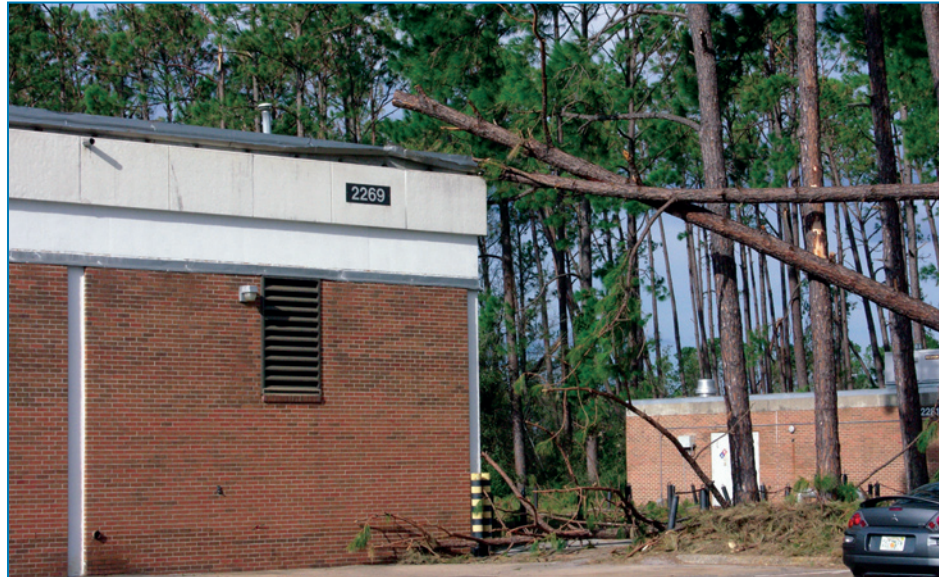
The roof membrane on this hospital's materials management facility was ruptured by falling trees. Hurricane Ivan (Florida, 2004)

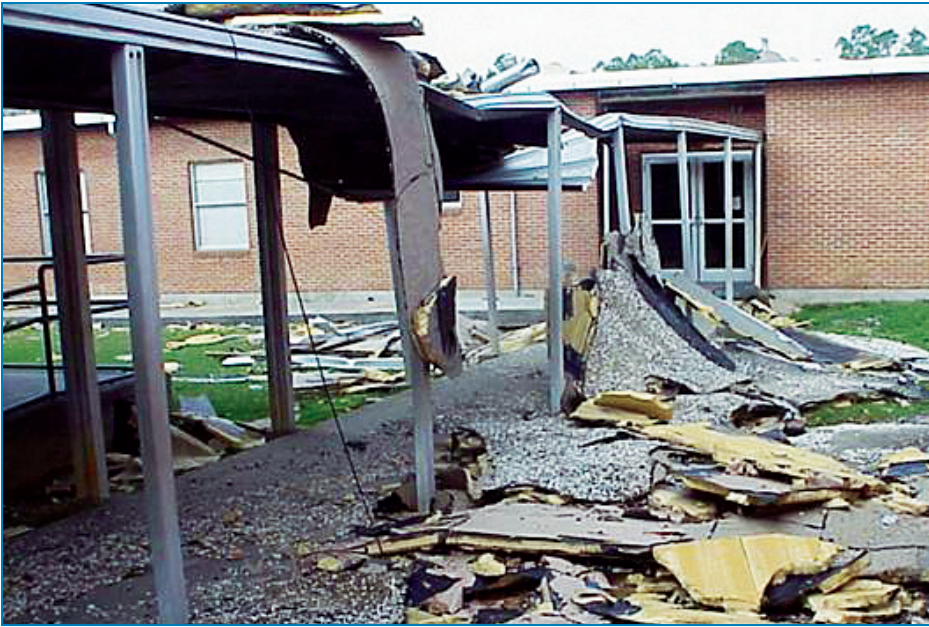
Figure 4-27:
Open walkways
do not provide
protection from
wind-borne debris.
(Hurricane Katrina,
Mississippi)

- In cases where multiple buildings are occupied during a storm, it is recommended that enclosed walkways be designed to connect the buildings. The enclosed walkways (above- or below-grade) are particularly important for protecting people moving between buildings during a hurricane (e.g., to retrieve equipment or supplies) or for situations when it is necessary to evacuate occupants from one building to another during a hurricane (see Figure 4-27).

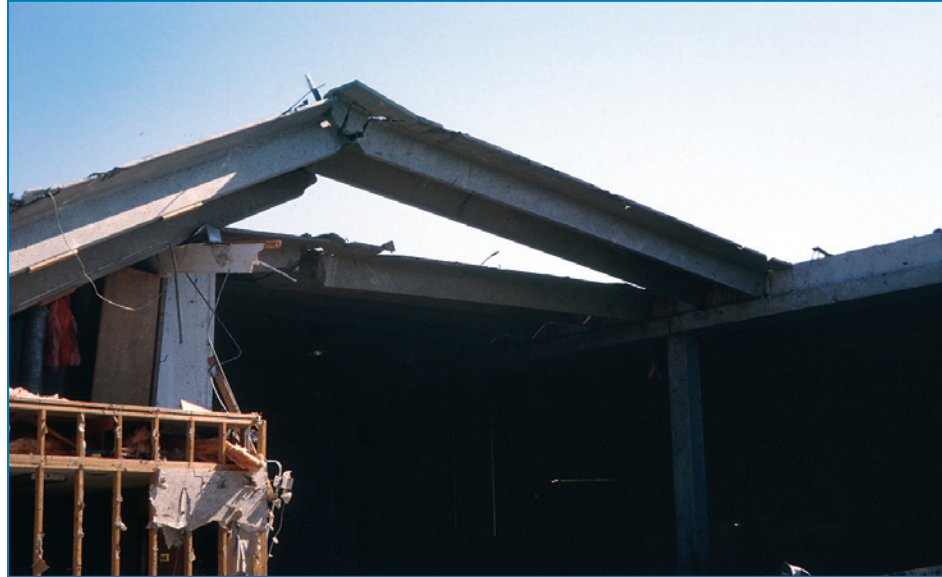
Figure 4-32:
Twin-Tee roof panel
lifted as a result of
the combined effects
of wind uplift and
pre-tension. Tornado
(Missouri, May 2003)

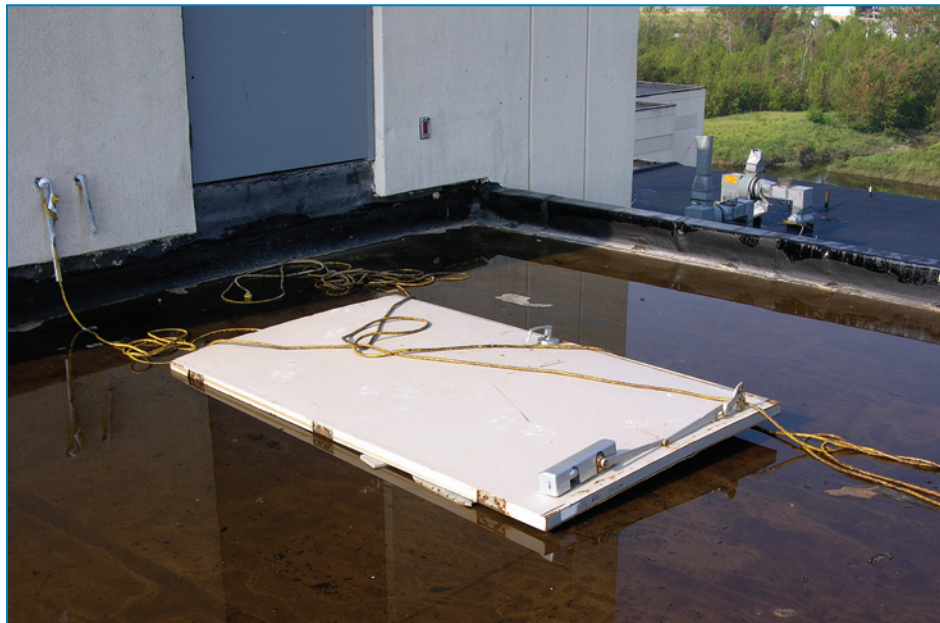
Figure 4-34:
Door on a hospital penthouse blown off its hinges during Hurricane Katrina (Mississippi, 2005)

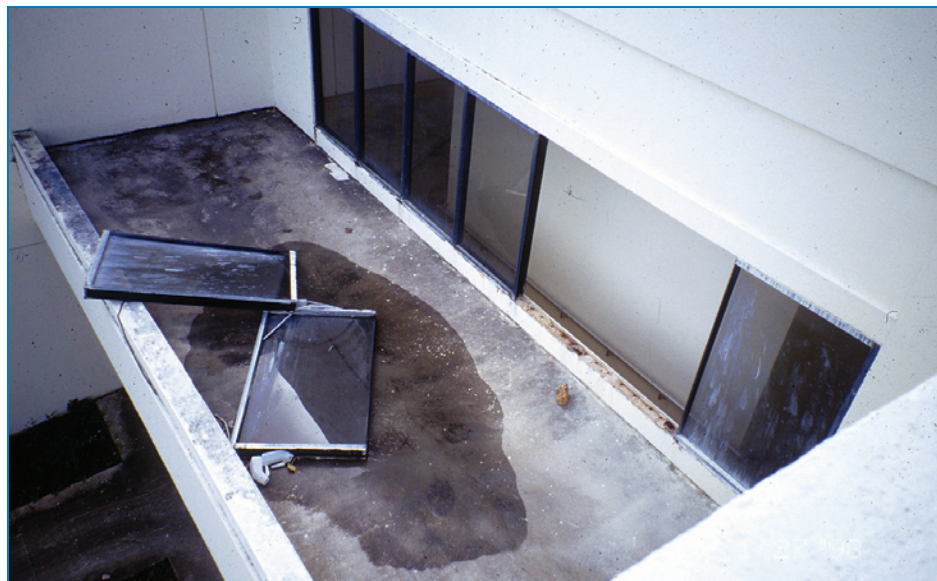
Two complete windows, including frames, blew out as a result of an inadequate number of fasteners. Typhoon Paka (Guam, 1997)

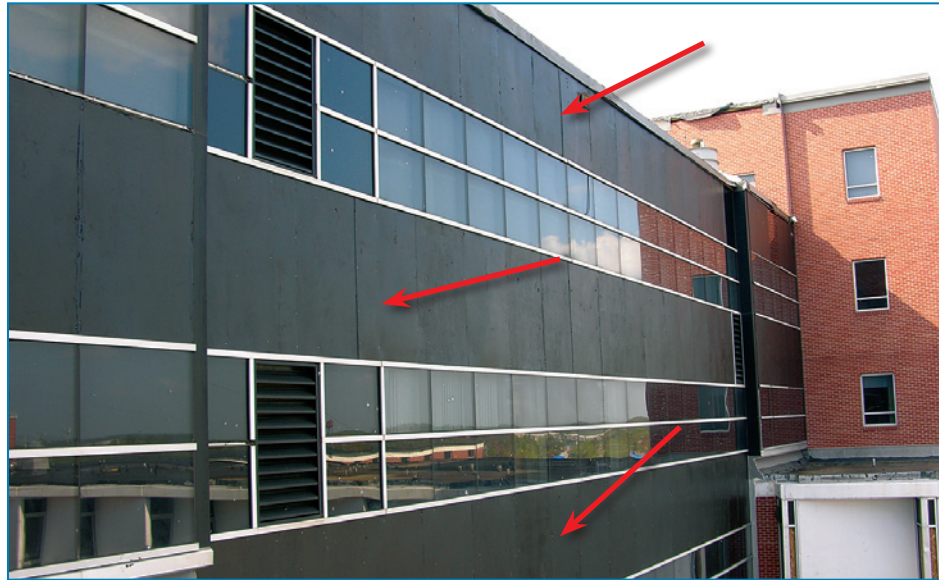
Figure 4-46:
Plywood panels (black continuous bands) installed after the glass spandrel panels were broken by roof aggregate.⁹ Hurricane Katrina (Mississippi, 2005)

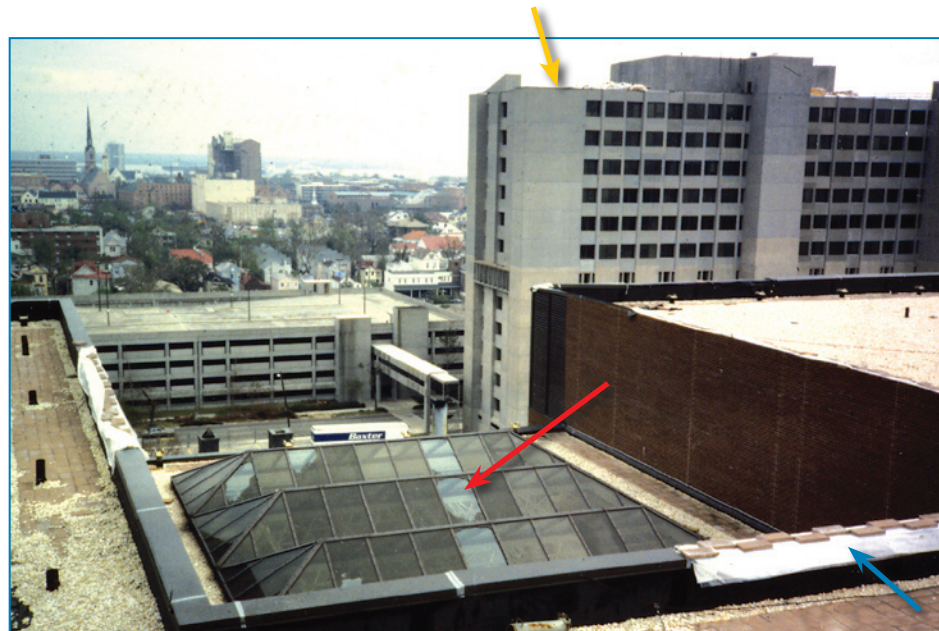
Figure 4-47:
The outer glass panes of the skylight were broken by roof aggregate (red arrow). Hurricane Hugo (South Carolina, 1989)

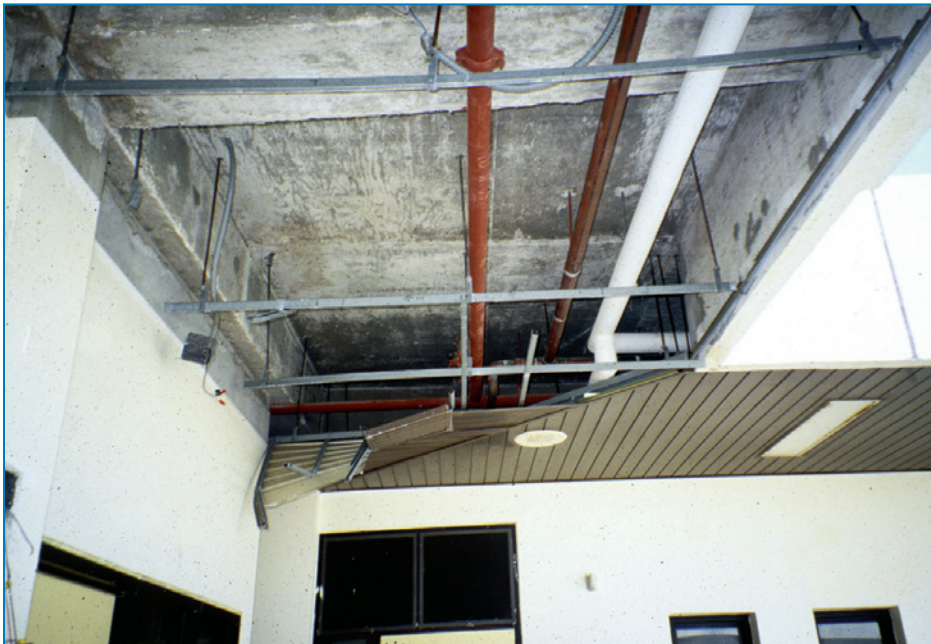
Figure 4-49:
This suspended metal soffit was not designed for upward-acting wind pressure. Typhoon Paka (Guam, 1997)

Where corrosion is a problem, stainless steel fasteners are recommended for wall and soffit systems. For other components (e.g., furring, blocking, struts, and hangers), nonferrous components (such as wood), stainless steel, or steel with a minimum of G-90 hot-dipped galvanized coating are recommended. Additionally, access panels are recommended so components within soffit cavities can be periodically inspected for corrosion or dry rot.

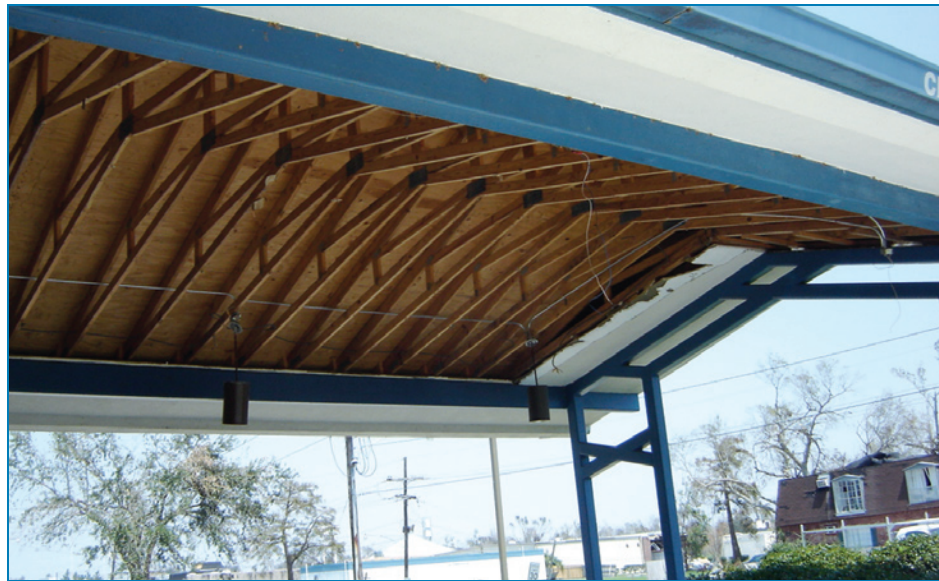
Figure 4-50:
Hospital canopy
damage. Hurricane
Katrina (Louisiana,
2005)

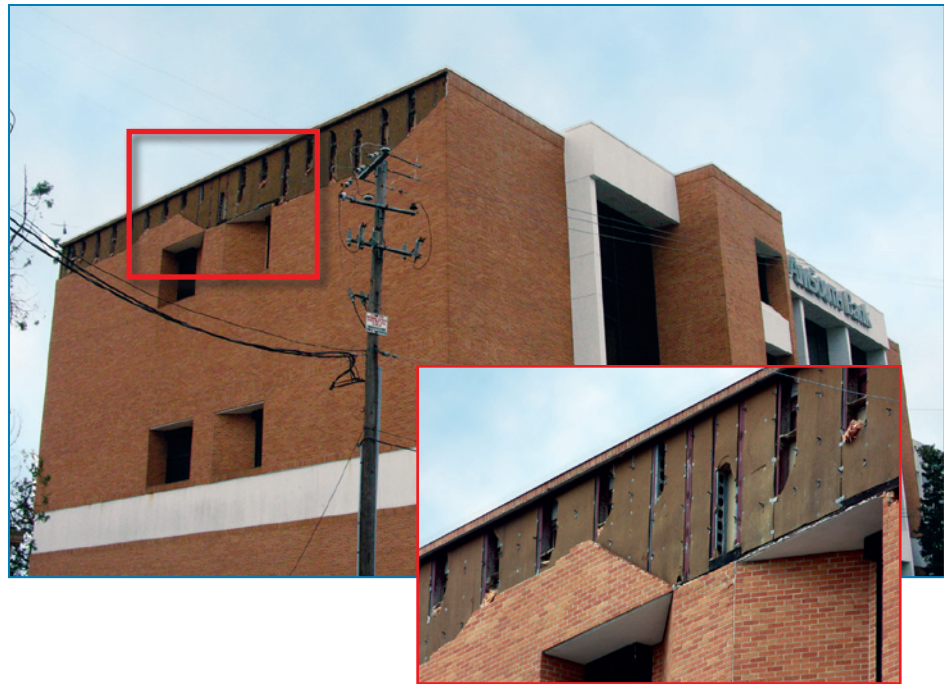
The brick veneer failure on this building was attributed to tie corrosion. Hurricane Ivan (Florida, 2004)

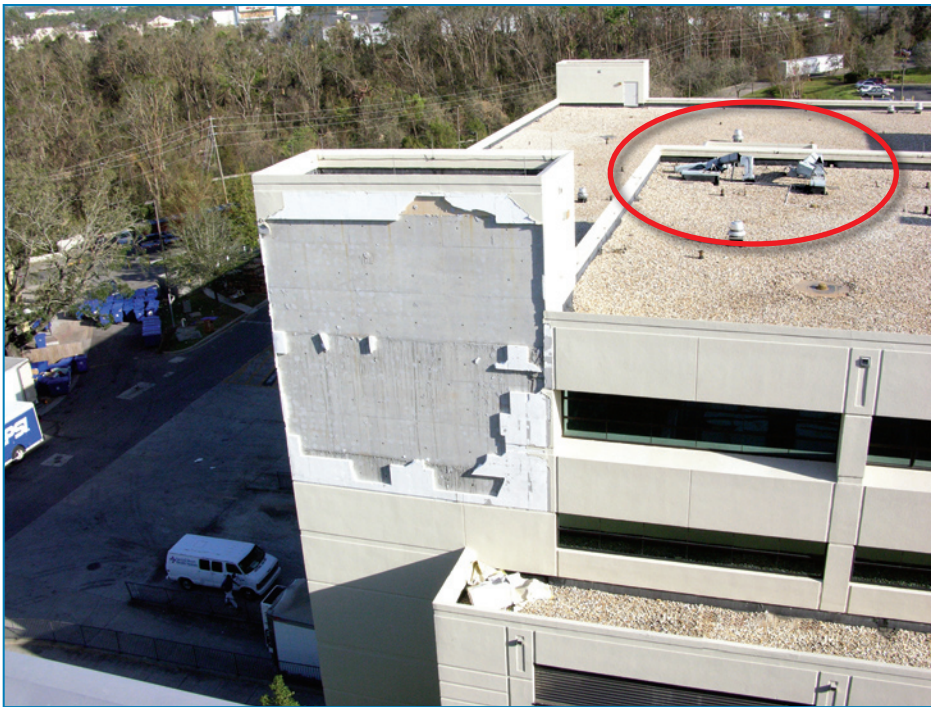
Figure 4-60:
EIFS blown off a cast-in-place concrete wall. Note the damaged rooftop ductwork. Hurricane Ivan (Florida, 2004)

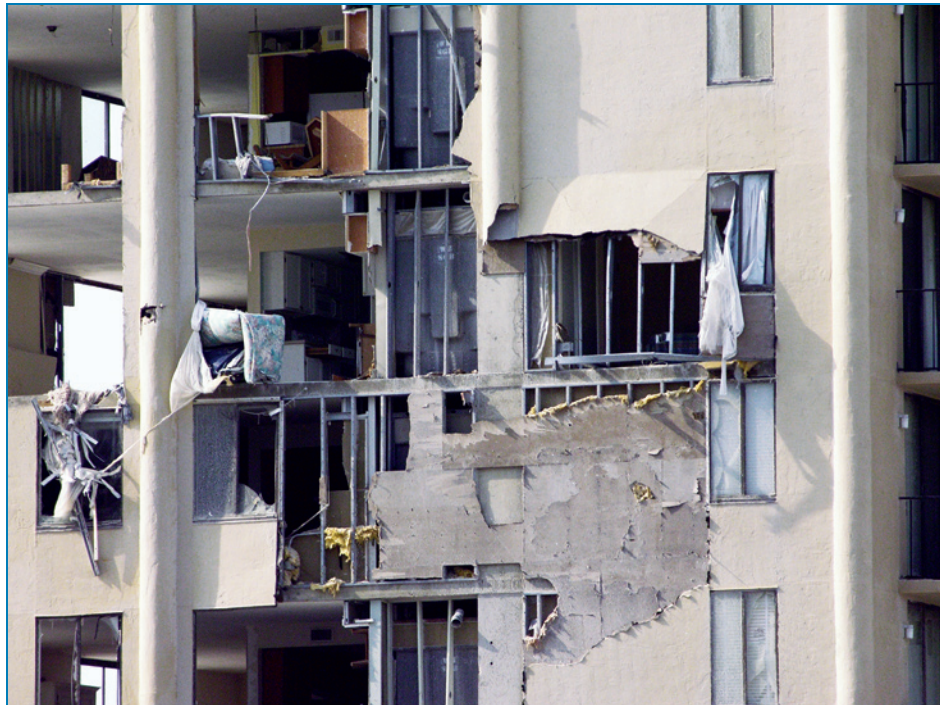
The stucco wall failure was caused by inadequate attachment between the stud tracks and the building's structure. Hurricane Ivan (Florida, 2004)

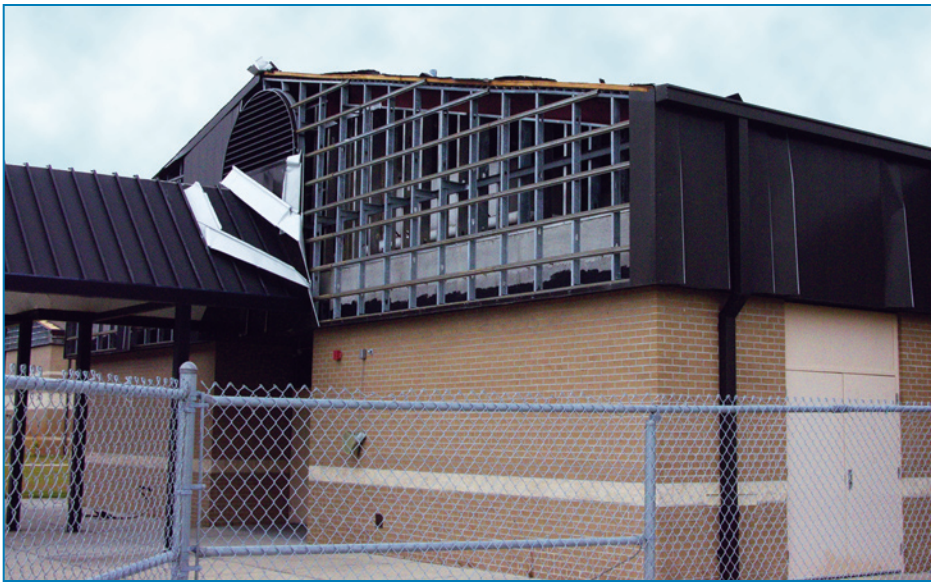
Figure 4-62:
The loss of metal wall panels allowed a substantial amount of wind-driven rain to penetrate this building. Hurricane Ivan (Florida, 2004)

To minimize water infiltration at metal wall panel joints, it is recommended that sealant tape be specified at sidelaps when the basic wind speed is in excess of 90 mph. However, endlaps should be left unsealed so that moisture behind the panels can be wicked away. endlaps should be a minimum of 3 inches (4 inches where the basic wind speed is greater than 120 mph) to avoid wind-driven rain infiltration. At the base of the wall, a 3-inch (4-inch) flashing should also be detailed, or the panels should be detailed to overlap with the slab or other components by a minimum of 3 inches (4 inches).

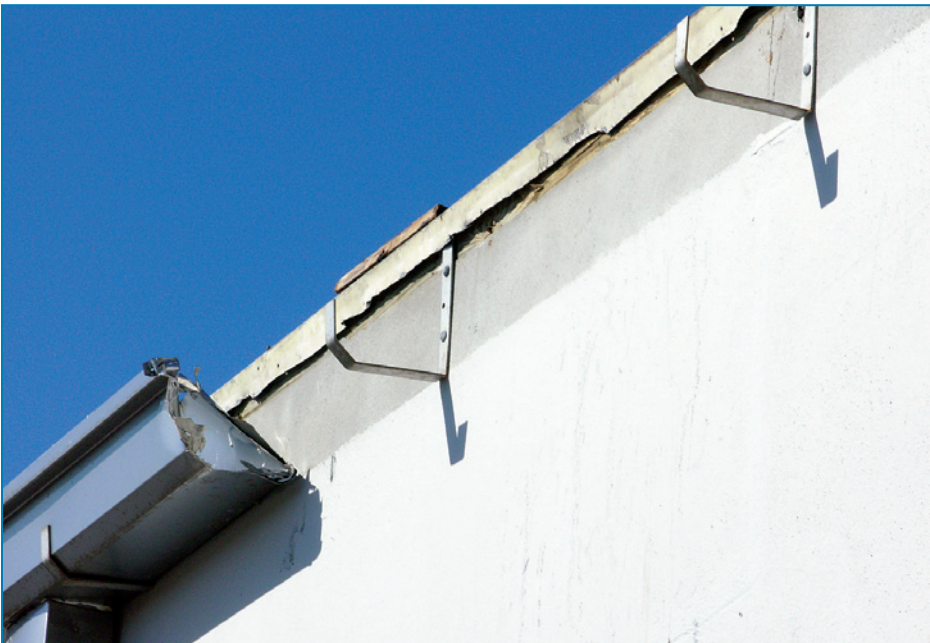
Figure 4-68:
This gutter, supported
by a type of bracket
that provides no
significant uplift
resistance, failed
when wind lifted it,
together with the metal
edge flashing that
lapped into the gutter.
Hurricane Francis
(Florida, 2004)

Special design attention needs to be given to attaching gutters to prevent uplift, particularly for those in excess of 6 inches in width. Currently, there are no standards pertaining to gutter wind resistance. It is recommended that the designer calculate the uplift load on gutters using the overhang coefficient from ASCE 7. There are two approaches to resist gutter uplift.

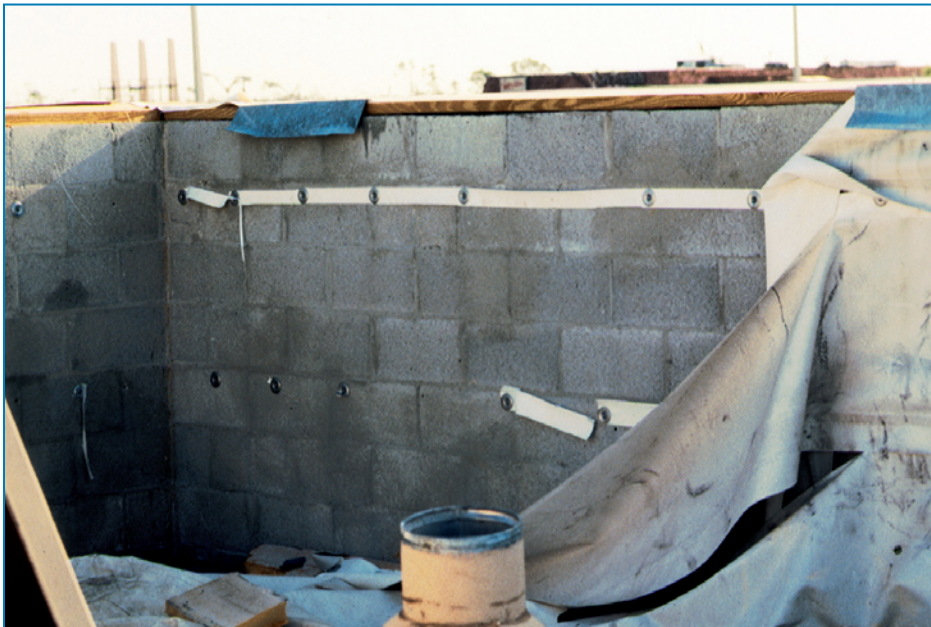
Figure 4-70:
If mechanically attached base flashings have an insufficient number of fasteners, the base flashing can be blown away. Hurricane Andrew (Florida, 1992)

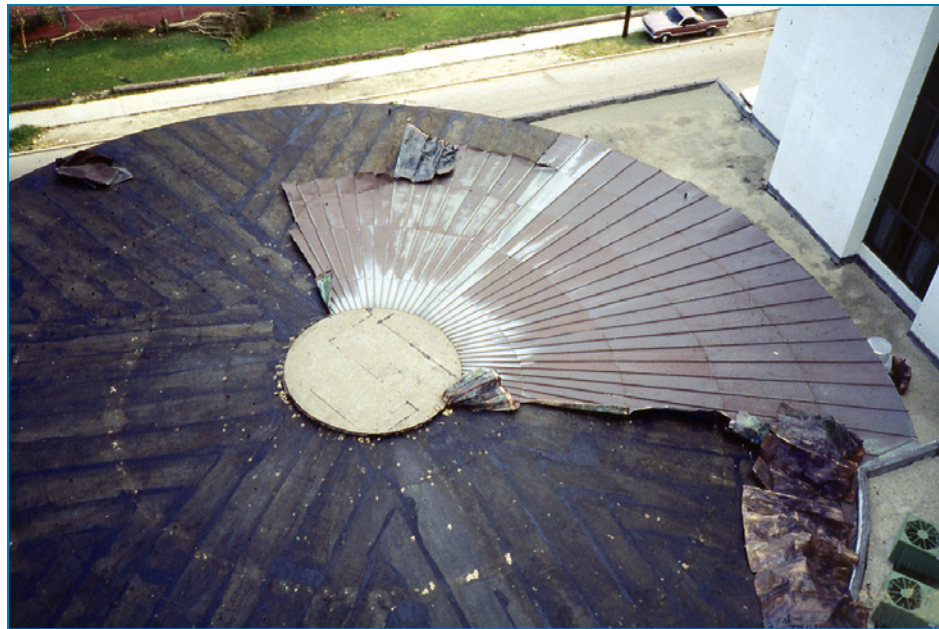
The secondary membrane prevented leakage into the ICU after the copper roof blew off. Hurricane Andrew (Florida, 1992)

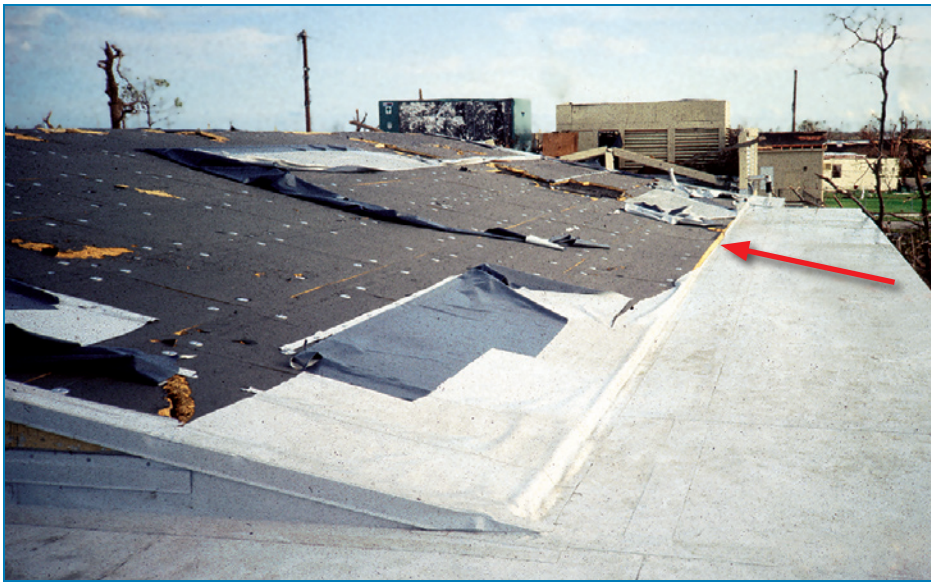
Mechanically attached and air-pressure equalized single-ply membrane systems are susceptible to massive progressive failure after missile impact, and are therefore not recommended for hospitals in hurricane-prone regions. At the building shown in Figure 4-75, a missile struck the fully adhered low-sloped roof and slid into the steep-sloped reinforced mechanically attached single-ply membrane in the vicinity of the red arrow. A large area of the mechanically attached membrane was blown away as a result of progressive membrane tearing. Fully adhered single-ply membranes are very vulnerable to missile puncture and are not recommended unless they are ballasted with pavers. At the hospital shown in Figure 4-76, several missiles, including exhaust fans and copings struck the roof.

Figure 4-75:
Mechanically attached single-ply membrane progressively tore after being cut by wind-borne debris. Hurricane Andrew (Florida, 1992)

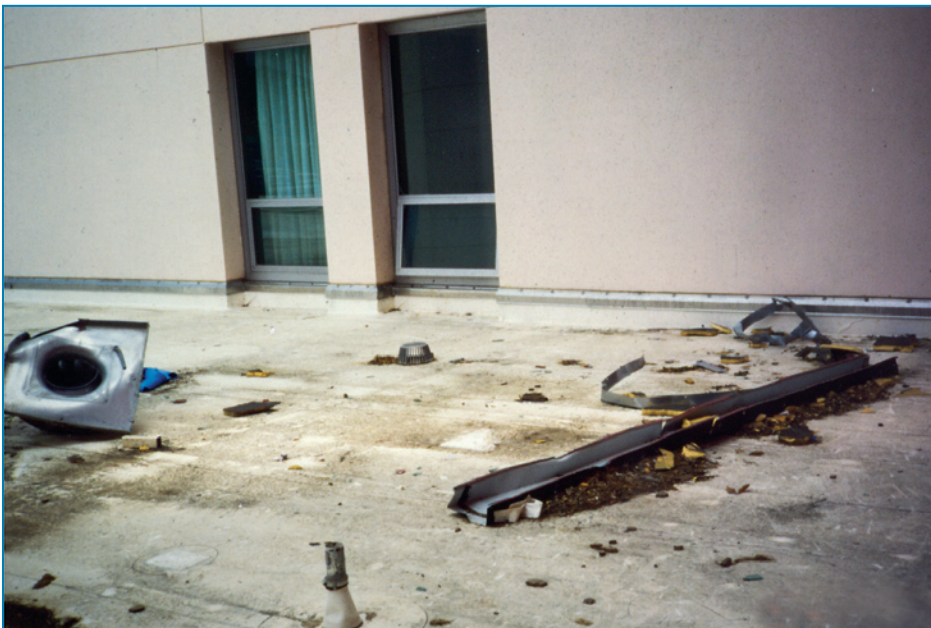
Figure 4-76:
This fully adhered single-ply roof membrane was struck by a variety of missiles. Hurricane Marilyn (U.S. Virgin Islands, 1995)

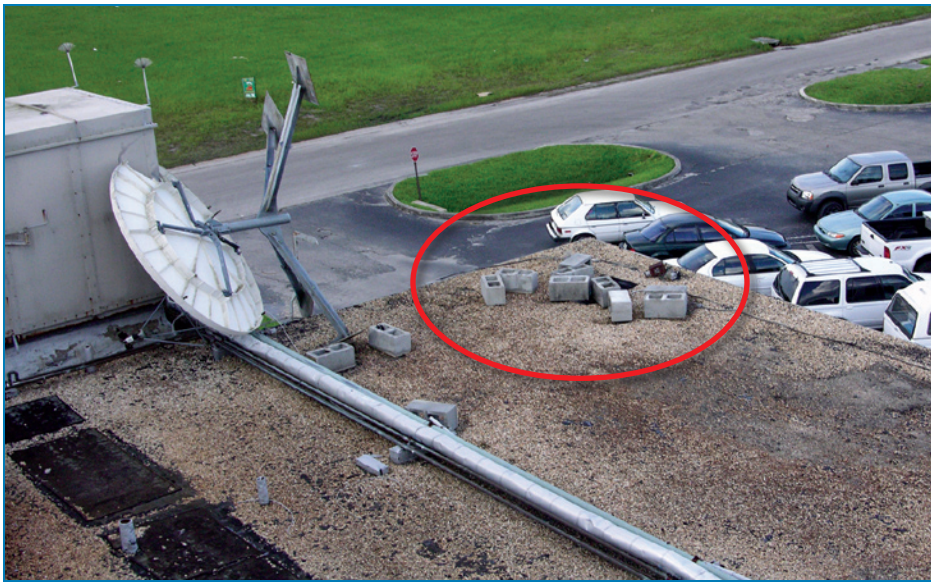
Figure 4-83:
This satellite dish was held down only with CMU. Note the displaced LPS at the corner (circled).

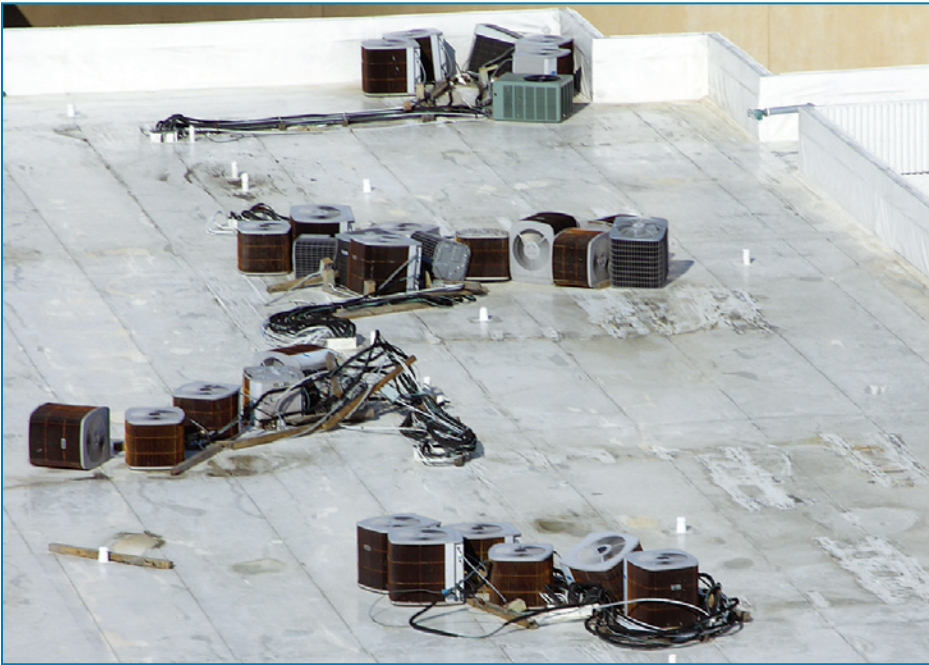
Figure 4-90:
Sleeper-mounted
condensers displaced
by high winds.
Hurricane Katrina
(Mississippi, 2005)

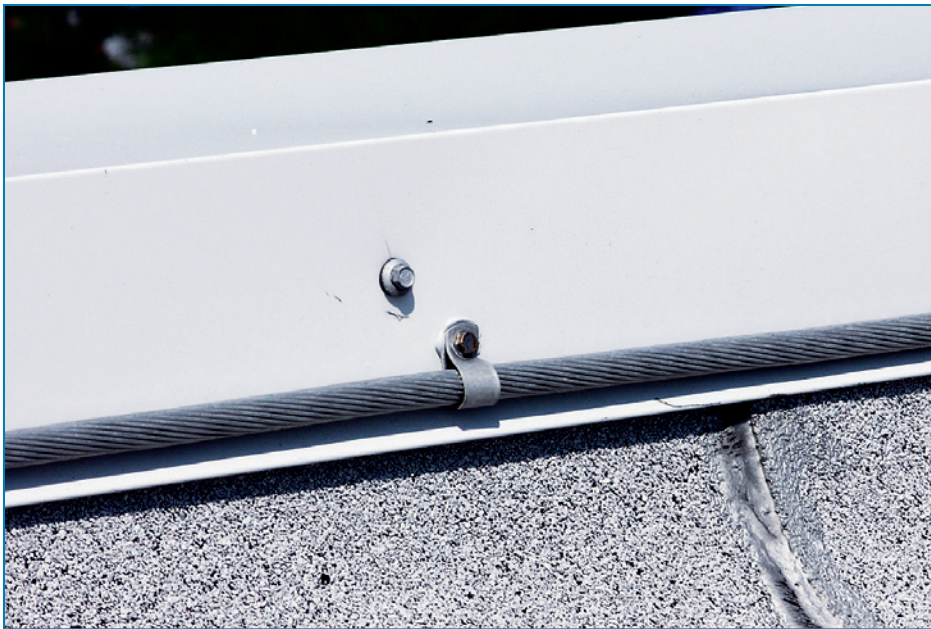
Figure 4-101:
This conductor was attached to the coping with a looped connector. Hurricane Katrina (Mississippi, 2005)

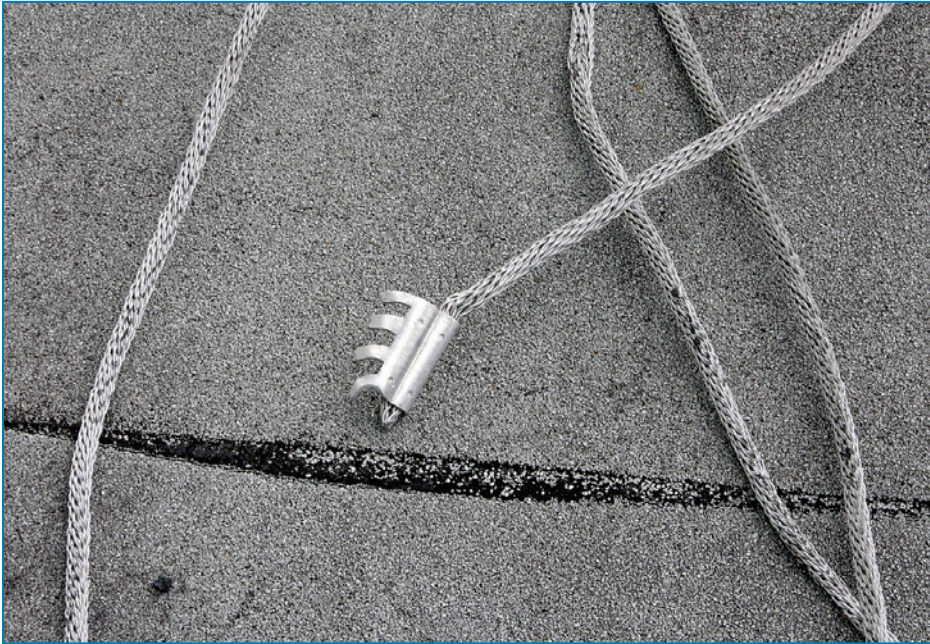
Figure 4-104:
If conductors detach from the roof, they are likely to pull out from pronged splice connectors. Hurricane Charley (Florida, 2004)

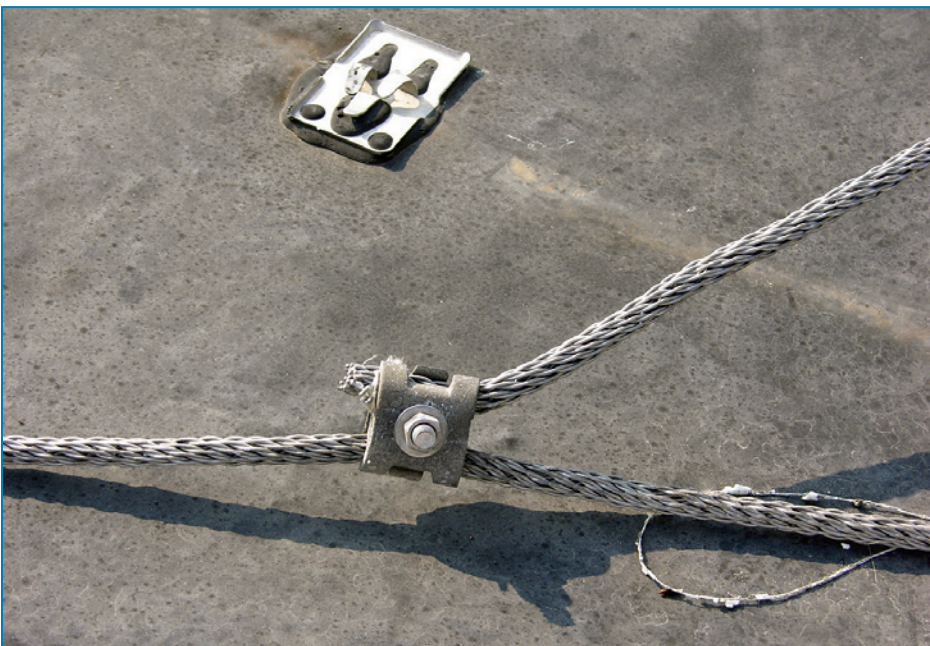
Figure 4-105:
Bolted splice connectors are recommended to prevent free ends of connectors from being whipped around by wind. Hurricane Katrina (Mississippi, 2005)

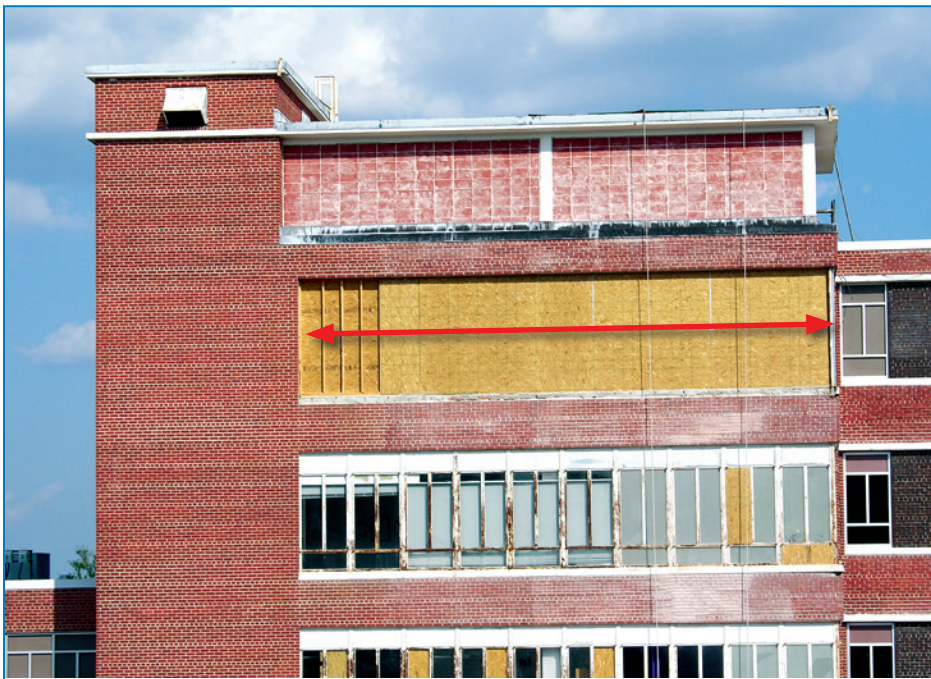
Figure 4-115:
Wind pressure caused the window frames on the upper floor to fail (red arrow). Hurricane Katrina (Mississippi, 2005)

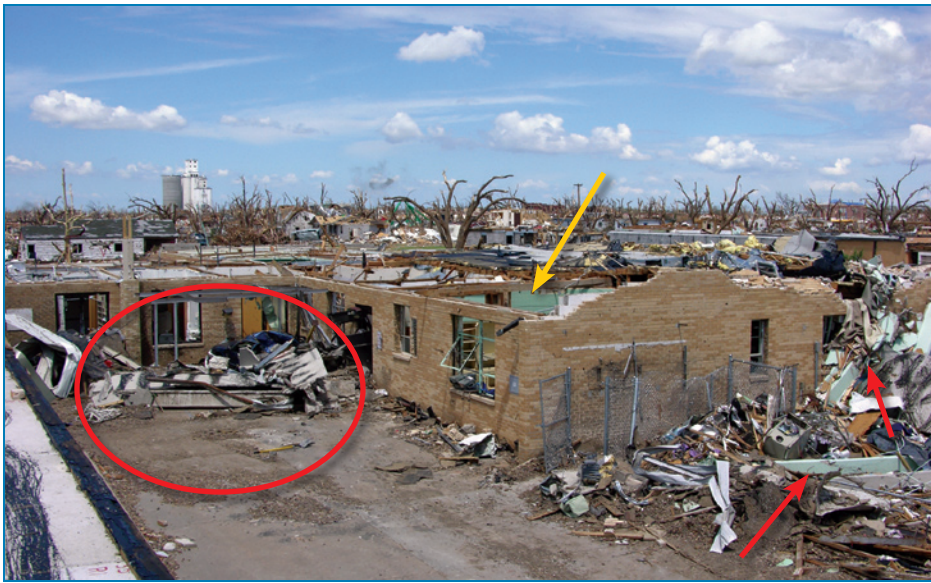
Figure 4-133:
The missing tee shown in Figure 4-132 landed about 80 feet away (red oval). The red arrows show tees that were blown from the ambulance garage. Note the missing wood roof structure on the 1982 addition (yellow arrow).

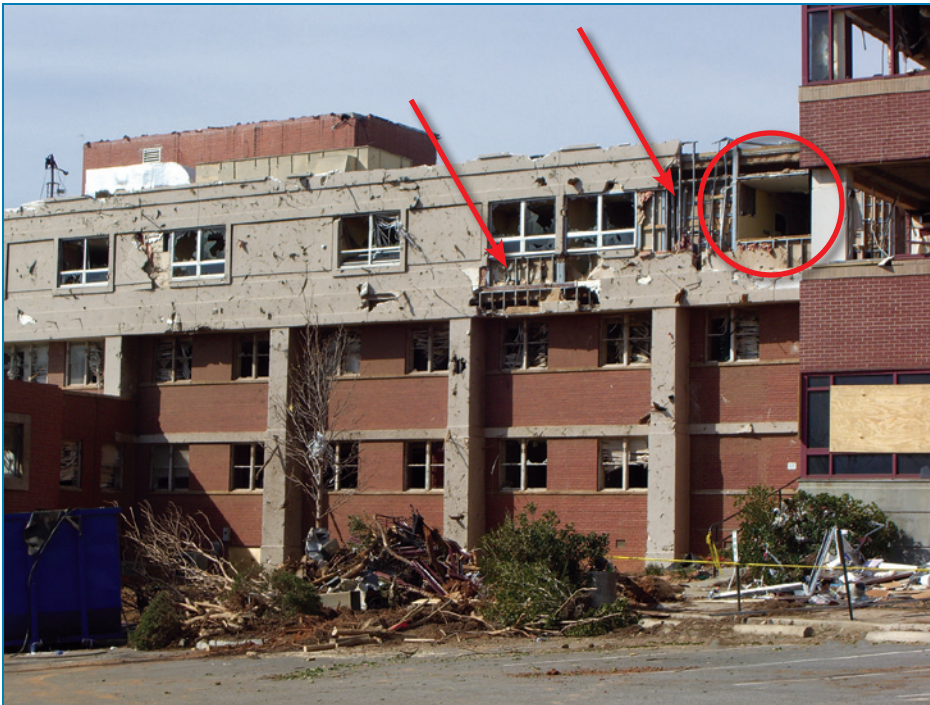
Figure 4-145:
One window frame was blown away (red circle). The EIFS was penetrated by many missiles, and in some areas, the entire wall (except the studs) was blown away (arrows).

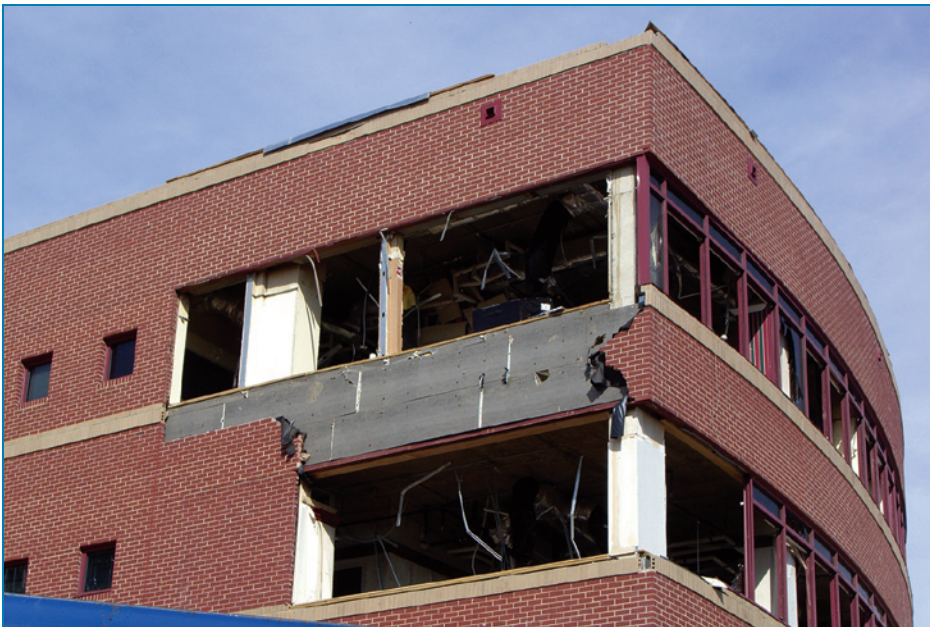
Figure 4-146:
Several of the window frames were blown away, along with some of the brick veneer (1999 addition).

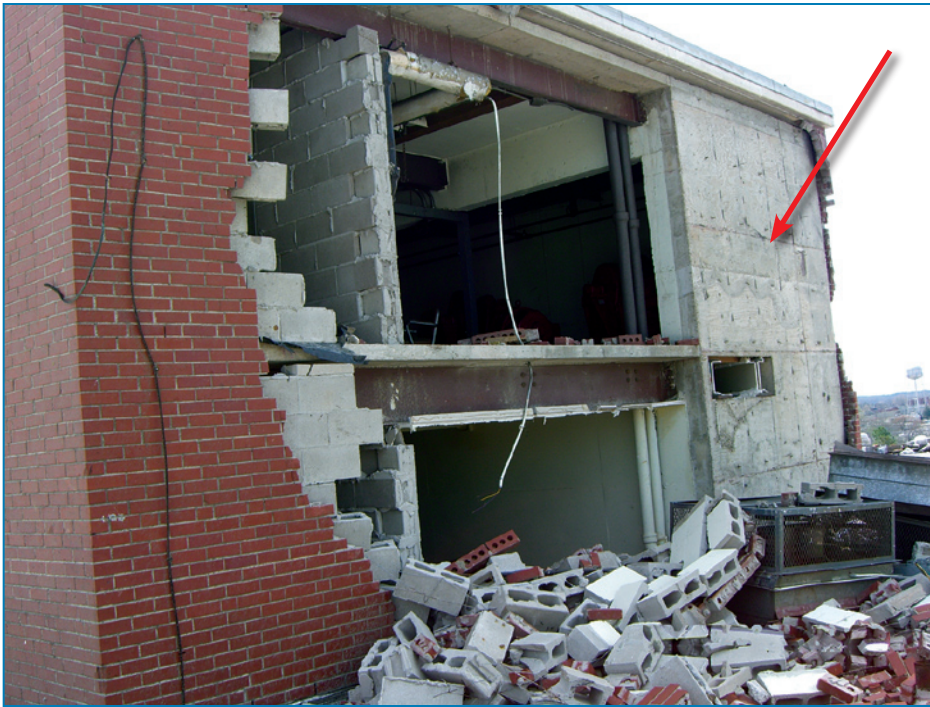
Figure 4-148:
Collapsed brick veneer/CMU wall at a mechanical room. The cast-in-place concrete wall (arrow) remained, but the brick veneer was blown away.
